State of California — The Resources Agency DEPARTMENT OF PARKS AND RECREATION PRIMARY RECORD		Primary	
		HRI #	
		Trinomial	
		NRHP Status Code	
Other			
Review Code		Reviewer	Date

*Resource Name or #: (Assigned by Recorder) 5001 S. Soto Street

*P11. Report Citation: (Cite survey report and other sources, or enter "none.") Malburg Generating Station Project Cultural Resources Inventory Report

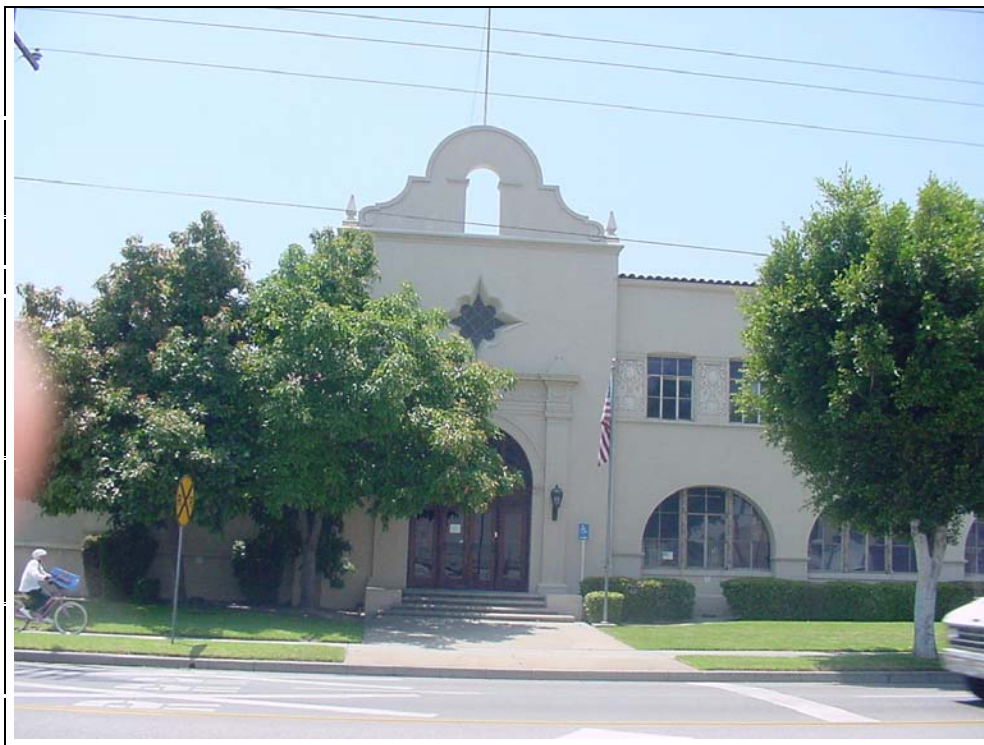
The Orval-Kent Food Company building is designed in the California mission style. The structure is flat-roofed. Atop the façade is a molded parapet with molded coping, two small spires adorn the ends and rest upon the narrow cornice work. Spanish style tile coping also runs the along the roof course throughout the rest of the building. Second story windows are recessed with nine-pane swing-out windows. A quatrefoil window with stained glass is centered in the upper section of the façade. The entryway and lower story windows are framed by Romanesque arches. Two pilasters are positioned on either side of the wood and glass doors. The exterior is entirely of textured stucco and is in good to excellent condition.

View facing west.
